TECHNICAL BULLETIN 035

25/03/2010

VAG 1.4 & 1.6 16V / SYNCHRONOUS DRIVE / INSTALLATION INFO

GATES REFERENCE:
5565XS & related kits.

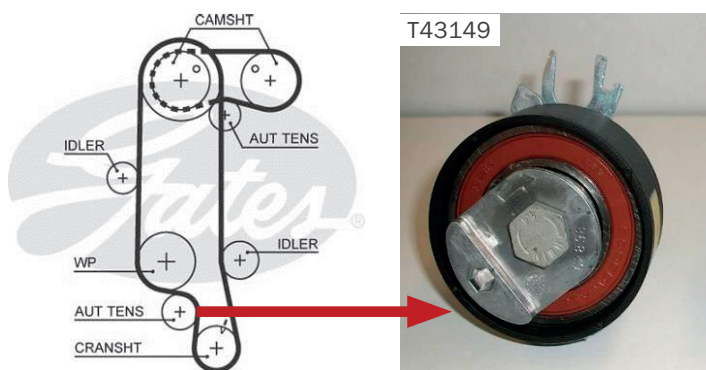
FIG. 1

Fig. 1 shows the 2 different versions of the automatic tensioner (for the main drive) to be found in our kits. They are interchangeable.

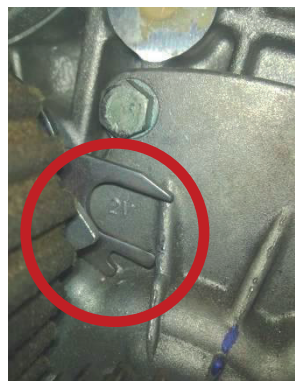
FIG. 2

Any incorrect position of the locating lug (Fig. 2, 3 and 4) will lead to an incorrect belt tension or to the fact the belt cannot be tensioned correctly.

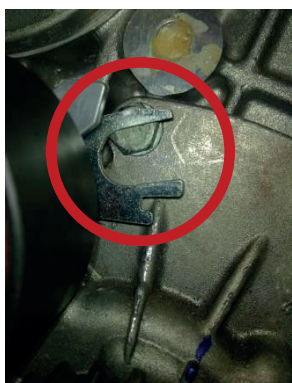
FIG. 5

If the tensioner is torqued up while the locating lug is sitting on the bolt's head (Fig. 5 and 6), this will lead to a deformation of the lug (Fig. 7), an incorrect torque of the tensioner bolt and possible tensioner misalignment.

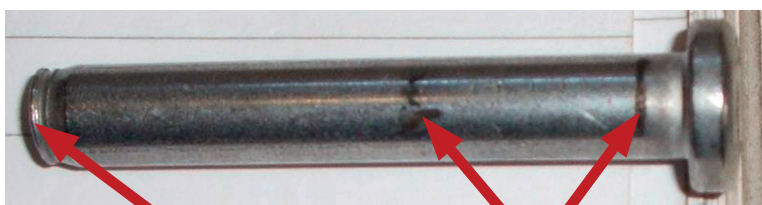
FIG. 8

The incorrect (too low) torque can lead to the bolt coming undone (due to vibrations) resulting in the load being transferred to the mounting bolt shank, causing it to shear (Fig. 8).

Bolt sheared off

Tensioner contact marks

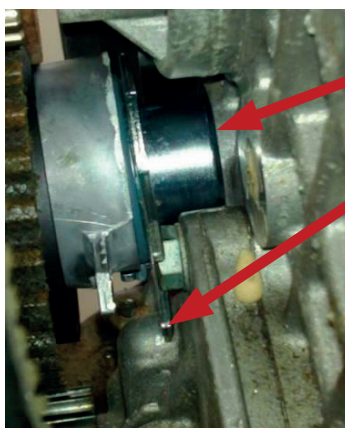
FIG. 9

Though the locating lug is correctly placed, possible incorrect sitting of the tensioner against the engine block after the tensioner bolt is torqued, leaving a gap between the tensioner and the engine block (Fig. 9).

Gap

Not far enough over bolt head

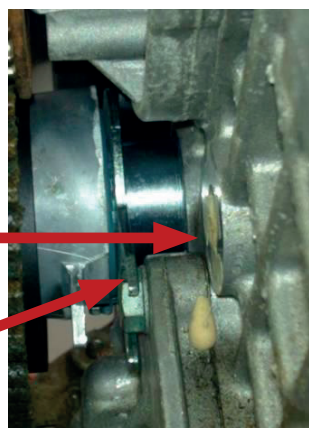
FIG. 10

No gap

Good position

Tighten the tensioner bolt finger tight assuring it's correctly placed (Fig. 10). Install a new PowerGrip® belt.

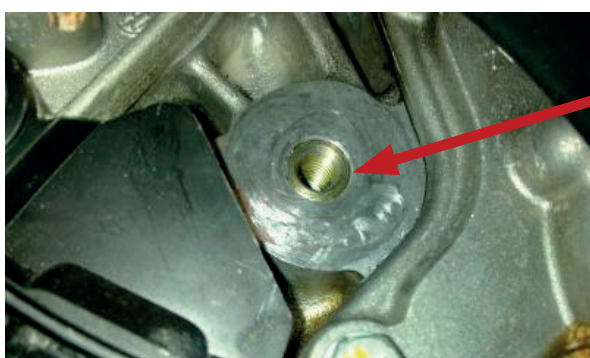
FIG. 11

- deformation of the tensioner leading to overheating of the bearing
- damage of the thread in the alloy engine block, leading to the need of a thread repair (Fig. 11)
- bolt rupture

Repaired thread

Make sure the thread in the engine block is undamaged and clean.

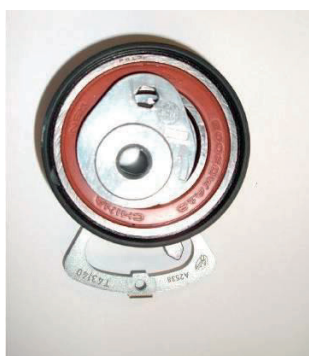
FIG. 16

Fig. 16 shows the automatic tensioner for the cam-cam drive.

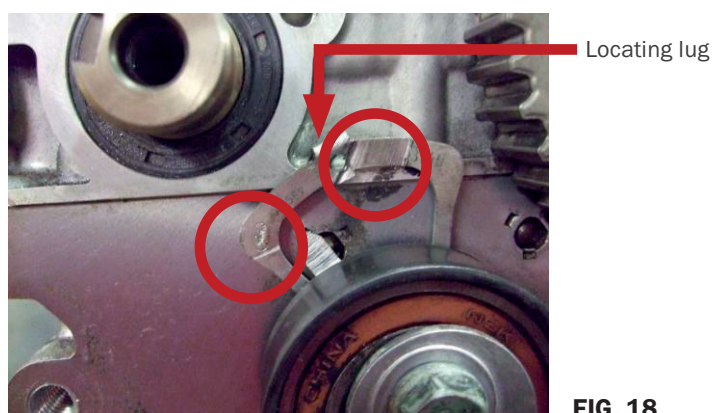
FIG. 18

It is clear an incorrect position of the locating lug will lead to problems like tensioner misalignment with drive failure as a result.

In one case the tensioner was mounted upside down, with the locating lug trapped behind a part of the cylinder head at 11 o' clock (Fig. 18). When bolting on the tensioner, the back plate deformed, because there was no hole for the lug to fit in.

As a result, the left hand side cam sprocket and the timing belt were touching the back plate, and the belt edge was 'eaten' away until the belt broke. The marks on the tensioner back plate (Fig. 18) and the debris on the inside of the drive cover (Fig. 19) were the clear witnesses of this destruction process.

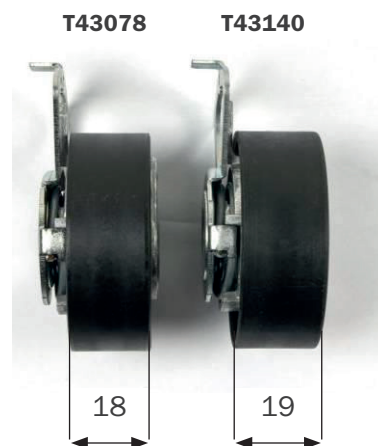
FIG. 20

The pulley width of the tensioner T43078 is 18 mm, for the T43140 the width is 19 mm (Fig. 20).

The main difference is to be found inside the tensioner. Requirements from OE on this tensioner resulted in two different "internal" constructions.

These tensioners are NOT interchangeable.

Check the online catalogue for the correct parts per application.
